(6) PHASE I INSPECTION REPORT  
NATIONAL DAM SAFETY PROGRAM.

City of Utica Reservoir 5 (Inventory Number NY 199)  
Mohawk River Basin, Oneida County, New York.  
Phase I Inspection Report

Name of Dam City of Utica Reservoir 5 NY199

PHASE I INSPECTION REPORT  
NATIONAL DAM SAFETY PROGRAM  
NAME OF DAM - CITY OF UTICA RESERVOIR 5 ID# - NY 199

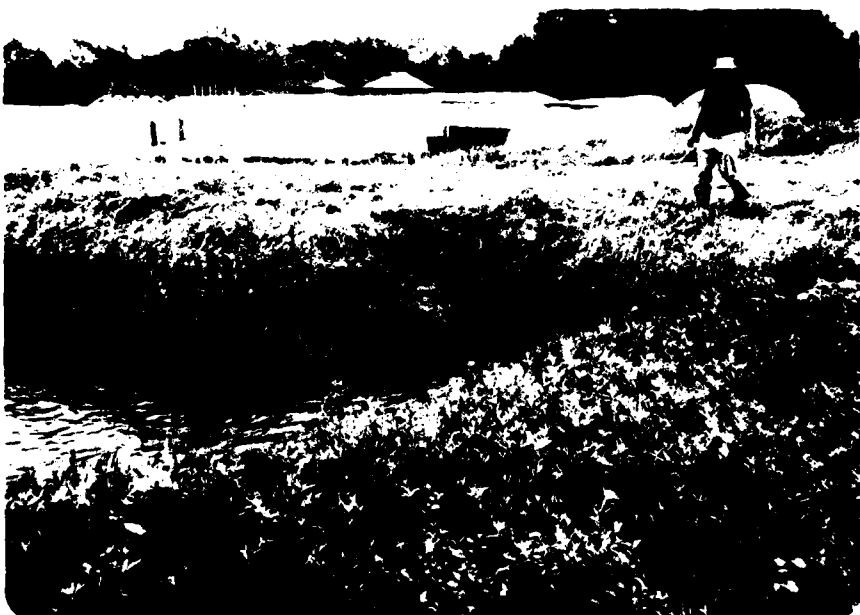
3. Outlet of Reservoir #5.

The outlet of the impoundment consists of a 20 inch diameter clay pipe. This pipe is in operating condition at the present time.
